PHOTOGRAPHIC INTERPRETATION REPORT

# SELECTED TRANSPORTATION AND INFILTRATION COMPENDIUM

CHANGES IN NORTH VIETNAM ELECTRIC POWER FACILITIES

NPIC/R-7/68 JANUARY 1968

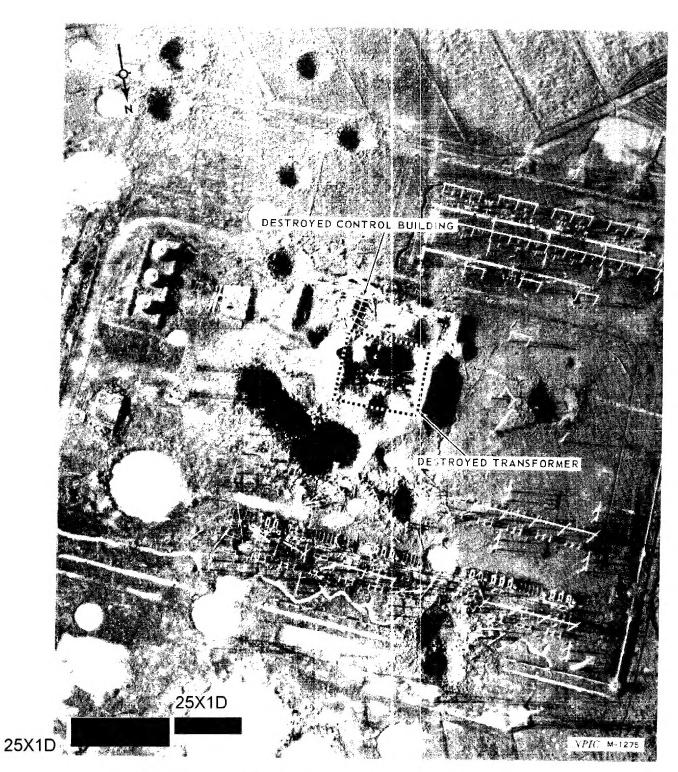
FIGURE 2. HA NOI TRANSFORMER SUBSTATION, DC 16 ANH, NORTH VIETNAM

Four of the six major 110 kv substations are inoperative due to the destruction and/or removal of their transformers: Ha Noi Transformer (Figure 2); Ha Dong Transformer 25X1A Substation Dong Anh, I (Figure 3); Hai Phong Transformer Substation Mong (Figure 3); Hai Phong Transformer Substation, 25X1A Substation, 1 25X1A I (Figure 5). In addition, the control building has  $\overline{25}X1A$  Duong, I been partially dismantled at Nam Dinh Transformer Substation, 25X1A Figure 6). All five installations appear abandoned (compare pages D10 thru D21, NPIC/R-146/67 Southeast Asia Activity Report, Electric Power Facilities, North Vietnam, Oct 67, SECRET NO FOREIGN DISSEM EXCEPT 25X1C i

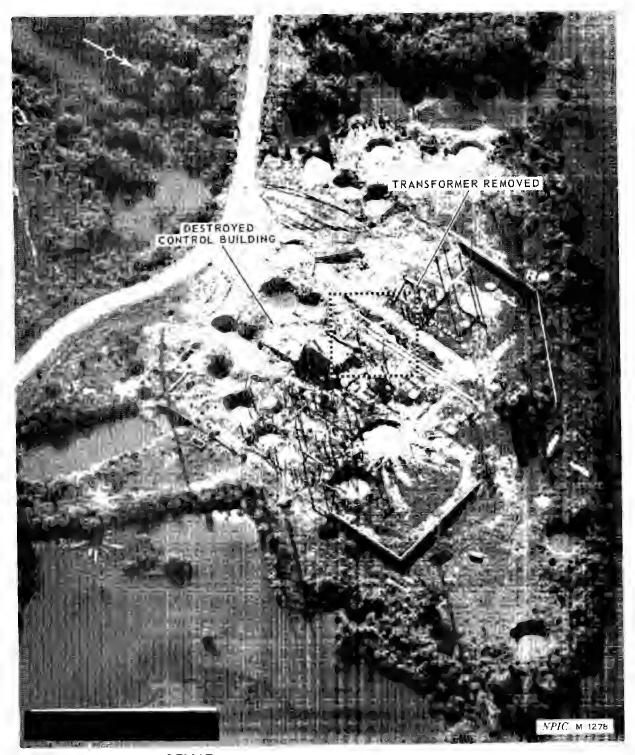
FIGURE 5. CAMPHA TRANSFORMER SUBSTATION, MONG DUONG, NORTH VIETNAM

The abandonment of the substations is probably a direct result of effective airstrikes against the powerplants and the resulting reduction in high voltage transmission capacity. The transformers removed from the substations could either be stored for the future reconstruction of the EPG or relocated at existing powerplants.

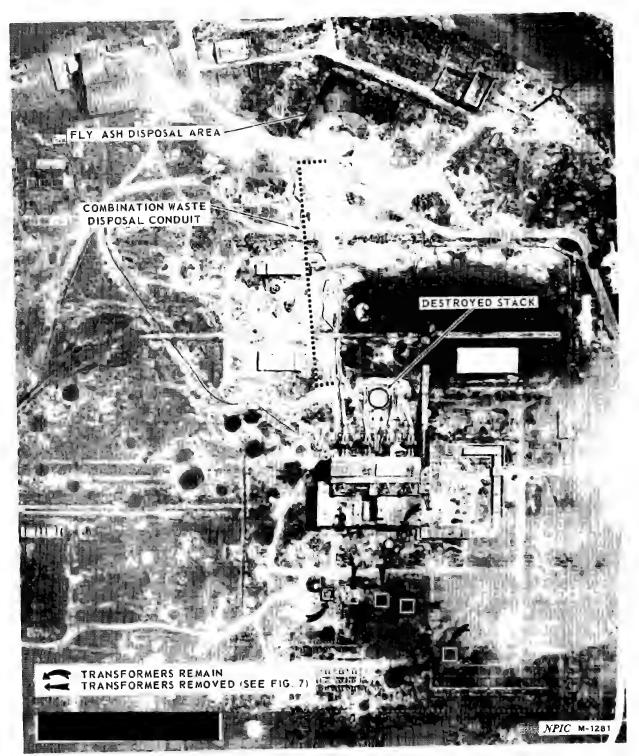
FIGURE 8. UONG BI THERMAL ELECTRIC POWERPLANT, NORTH VIETNAM

The powerplant waste disposal system is being modified to accommodate both fly ash (sludge) and gaseous materials in a single underground conduit, thereby eliminating the requirement for a main stack. This innovation was confirmed at Uong Bi where the flue extensions by-pass the destroyed stack and connect with a partially underground conduit terminating at the fly ash disposal area (Figure 8).

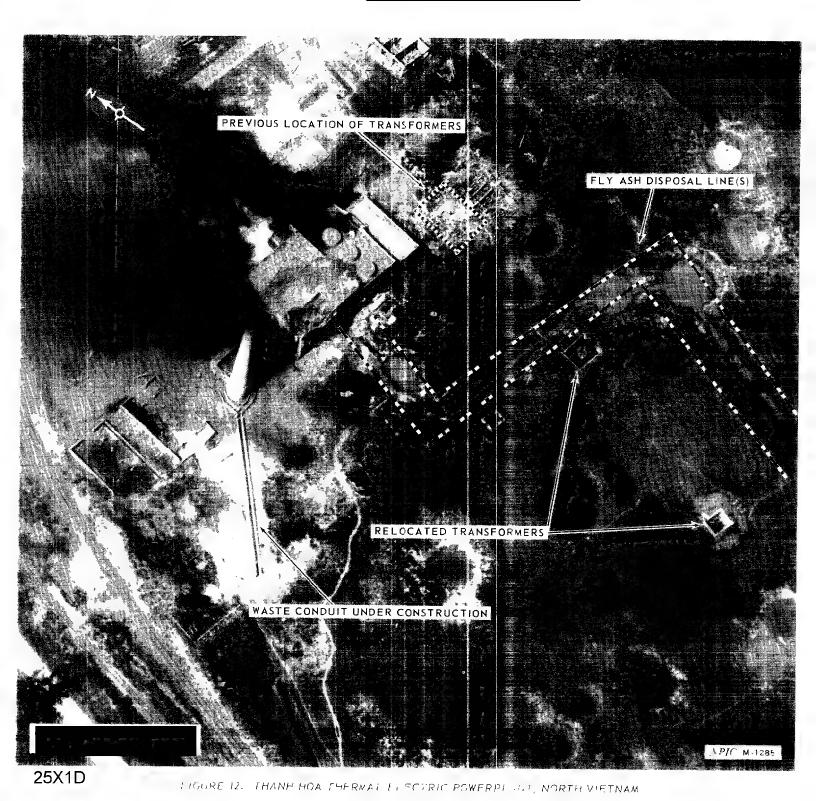
Construction of an underground conduit was begun at Thanh Hoa after airstrikes against that installation. This conduit also appears to extend from the flue system and by-pass the stack (Figure 12). Unlike those at Uong Bi and Viet Tri, it does not coincide with the previously existing fly ash disposal line. It may therefore have been intended to function only as a horizontal flue for the discharge of gaseous materials and not as a combined waste disposal line.
